## UPPER EAST FORK WATERSHED

The Upper East Fork watershed, located in the southeastern most portion of the Upper Sevier River watershed, is part of the Paunsaugunt Plateau. Six subwatersheds, encompassing 187,493 acres represent a variety of land ownership and uses (Fig. 4-33), as well as vegetation types.

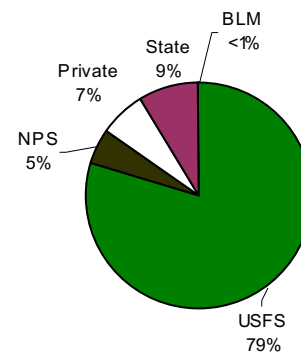
Fig. 4-32. The six subwatersheds within the Upper East Fork watershed are composed of state, federal, park service and private lands.

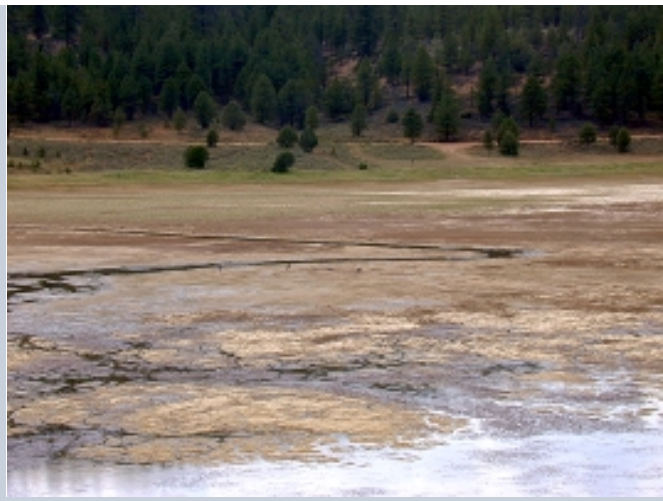
*Accelerated erosion occurs throughout much of the watershed, increasing downstream sediment transport.*

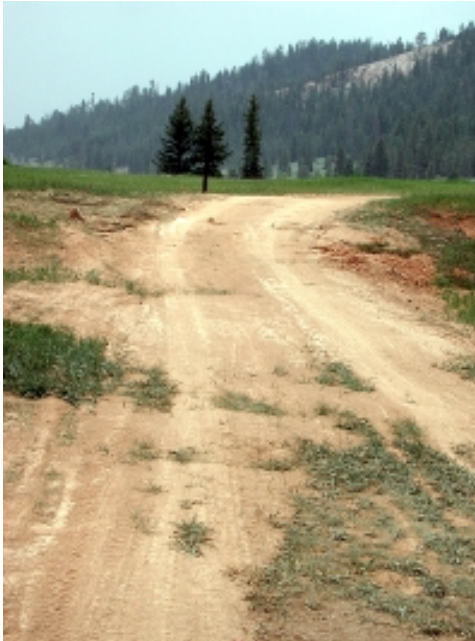
*Highly erosive soils, coupled with high road densities, are responsible for much of the erosion in riparian and upland areas.*
